REINFORCED AUTOCLAVED AERATED CONCRETE (RAAC)

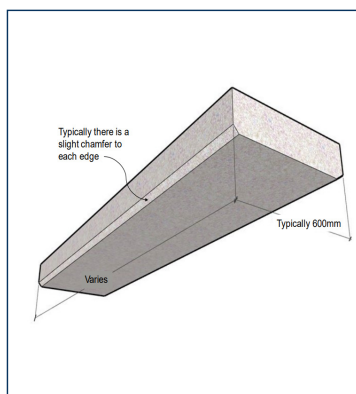
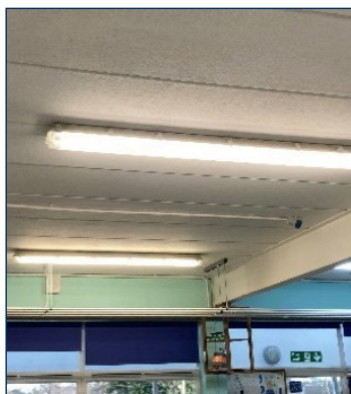
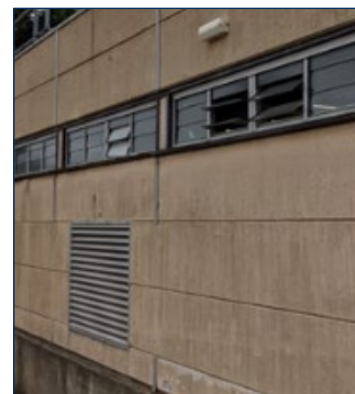
Taken from DfE Guidance document, dated August 2023.

- Concrete panels, typically 600mm wide
- Distinctive chamfer to the edge of the panels, forming a “V” shape where panels meet
- Appearance of white or light grey
- Lightweight and “softer” than traditional concrete – A screwdriver can be pressed into the panels and will leave an indentation.

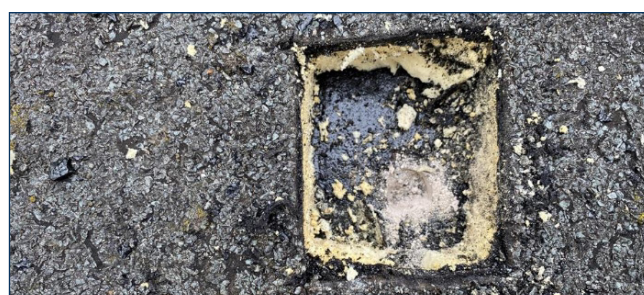
Core sample of flat roof, RAAC identified.

It may be necessary to undertake intrusive investigations should the inspection be inconclusive; an example again being a plaster/decorated finish to a solid ceiling/floor. Once confirmed as not an ACM, we shall discuss with our Client’s the potential for further intrusive investigations. In this instance, we would follow guidance from both The Standing Committee on Structural Safety (SCOSS) and The Institution of Structural Engineers. This would be a small and intrusive drill sample to assist in discreet locations. Given the potential softness of RAAC in contrast to traditional concrete, this must be undertaken with considerable care.
