RETROFITTING NON-TRADITIONAL PROPERTIES

It's estimated that some 1.5 million houses were built using non-traditional (non-trad) materials and methods of construction between the 1940s and the 1970s. Chartered Building Surveyor and PAS 2035 Retrofit Coordinator, Matthew Allcock, explains the key considerations for retrofitting these types of housing.

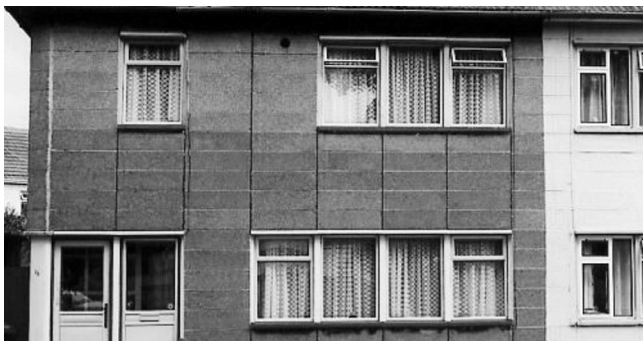
Name: Unity & Butterley

Type: PRC Construction

- Storey height precast concrete columns linked at first floor and eaves height by steel plate beams running front to rear
- Outer leaf of 75mm wide concrete Panels, inner leaf of concrete blockwork or dry lining
- Pitched roof constructed of timber or concrete rafters with a covering of tiles laid on asbestos boards

- External cladding resembles blockwork laid with continuous vertical joints.

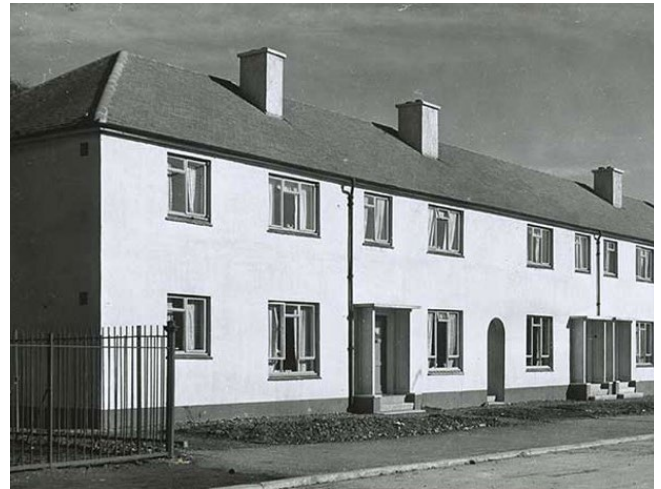
Name: Wimpey No Fines

Type: In Situ Concrete Construction

- Ten-inch (254mm) concrete shell cast in situ
- Cast in one operation using reusable formwork
- Ground floor either concrete or traditional timber joists and floorboards; first floor was made with traditional timber joists and floorboards
- Interior walls were sometimes a mixture of conventional brick and blockwork construction or timber studs and plasterboard (9mm), with load-bearing studs to suit first floor joist spans
- To weatherproof the structure, the external facade was rendered

- Geometric structure, regular grey finish, rice crispy walls!

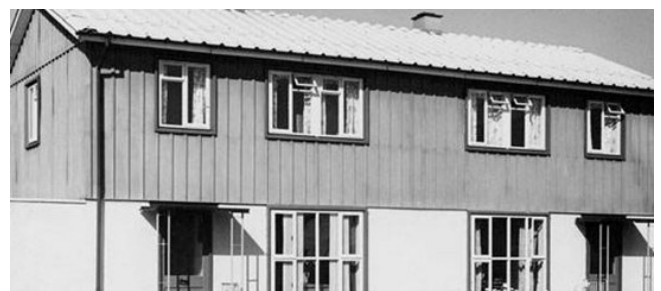
Name: British Iron and Steel Federation Housing (BISF)

Type: Steel Frame Construction

- Structural steel frame in light sections
- Sheet or lightweight cladding

- Ribbed metal sheeting to first floor external, metal surrounded window projecting from wall face, corrugated asbestos cement roof covering.

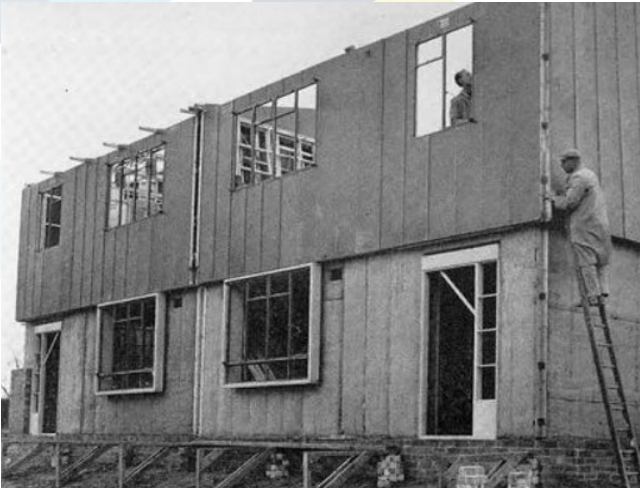
Name: Spooner

Type: Timber Frame Construction

- Built as bungalows and 2-storey semi-detached and terraced houses
- Having a steep, medium or shallow pitch gable roof covered with tiles, profiled steel or asbestos cement sheets

- Gable wall of a timber frame building will have a timber spandrel panel forming the gable panel
- Windows fixed to the frame, not to brickwork outer leaf may result in a deeper external reveal.

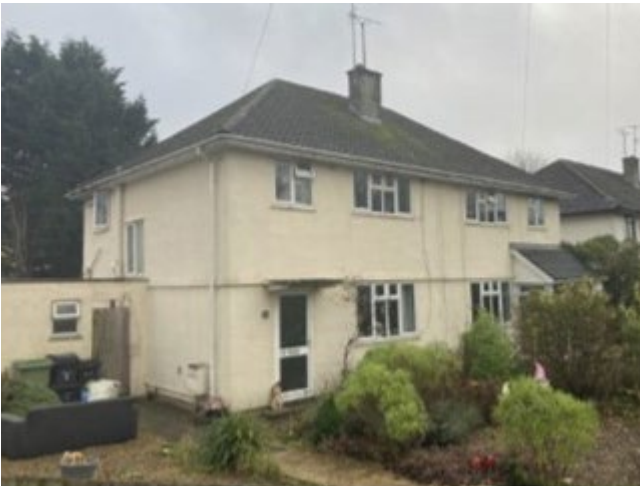
Name: Laing Easi Form

Type: In Situ Concrete Construction

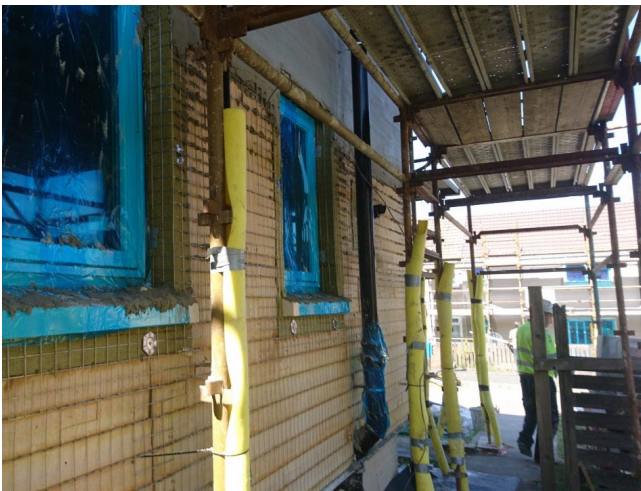
The construction of the unique panels used is based upon a core of rigid insulation set within a steel cage. The panels are strong and rigid yet are sufficiently lightweight for handling by one individual. They can be installed both horizontally and vertically and have a maximum spanning capacity of 3.6m.

The panels do not attach to the substrate but are instead fixed to the structure of the building itself. This, in effect, forms a new substrate which is structural in a reinforcing capacity – not load-bearing.

One potential specification is a Structural External Wall Insulation System (SEWI). The SEWI system provides a rigid, structurally continuous envelope around the property and various aesthetic finishes can be incorporated into the design.
